ASBESTOS MANAGEMENT SURVEY

Client Name:	Direct 365 Online Ltd
Client Contact:	Sasha Deegan
Client Address:	Direct 365 Online Ltd Oasis Business Park Skelmersdale WN8 9RD
Address of premises surveyed:	Kennington Park Academy 20 Kennington Park Gardens Kennington SE11 4AX
Type(s) of survey undertaken:	Management
Survey Date(s):	17/01/2019
Report No:	E-72310
Surveyor / Authorisation:	Andrew Rogers – Asbestos Surveyor
Report Date:	23/01/2019
Q.C Check by:	Andrew Rogers

Kennington Park Academy, 20 Kennington Park Gardens, Kennington, SE11 4AX

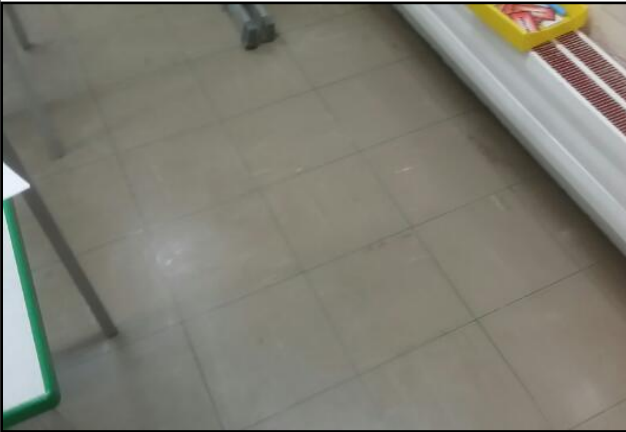
Room	Classroom 1			
Accessibility	Medium			
Material Description	Bituminous Product			
Material Position	Floor			
Status	Sampled			
Sample Ref	2			
Asbestos Type	Chrysotile			
Quantity	40 m ²			
Condition	Good Condition			
Comments	Bitumen adhesive	Recommendation	Label & manage	LOW RISK

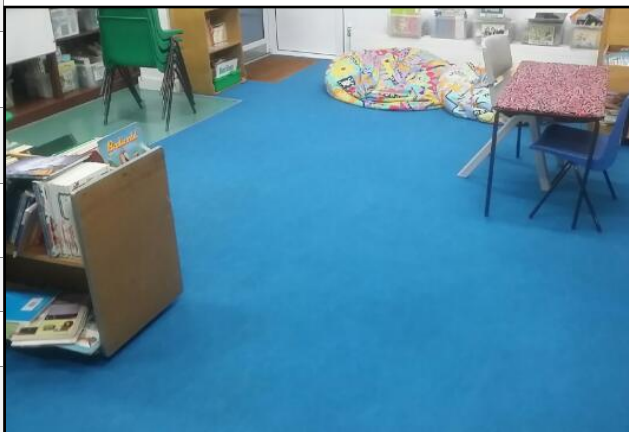
Room	Classroom 4			
Accessibility	Medium			
Material Description	Bituminous Product			
Material Position	Floor			
Status	X-referenced			
Sample Ref	2			
Asbestos Type	Chrysotile			
Quantity	50 m ²			
Condition	Good Condition			
Comments	Bitumen adhesive	Recommendation	Label & manage	LOW RISK

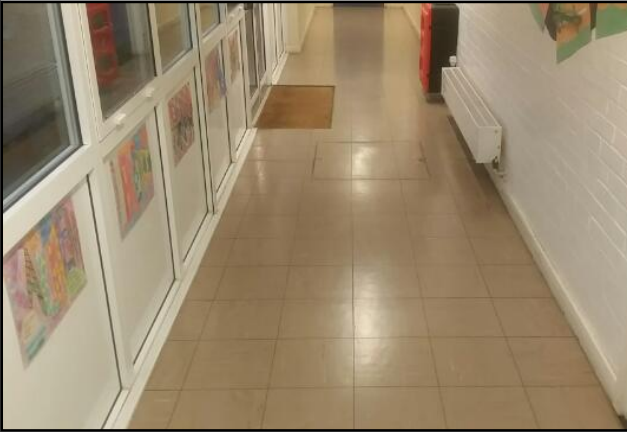
Building	Kennington Park Academy			
Room	Corridor 3

Accessibility	Medium			
Material Description	Bituminous Product			
Material Position	Floor			
Status	X-referenced			
Sample Ref	2			
Asbestos Type	Chrysotile			
Quantity	10 m ²			
Condition	Good Condition			
Comments	Bitumen adhesive	Recommendation	Label & manage	V.LOW RISK

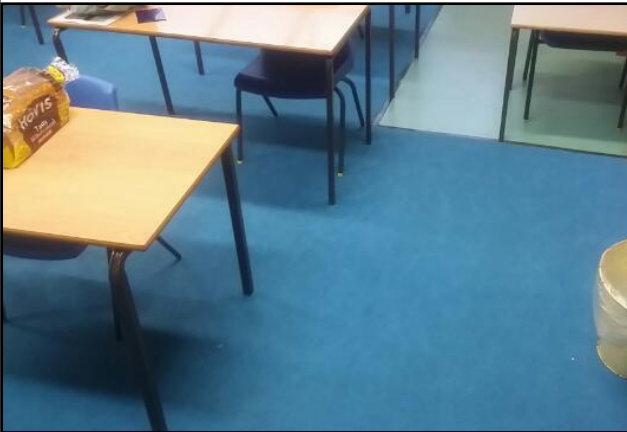
Building	Kennington Park Academy			
Room	Classroom 5

Accessibility	Medium			
Material Description	Bituminous Product			
Material Position	Floor			
Status	X-referenced			
Sample Ref	2			
Asbestos Type	Chrysotile			
Quantity	50 m ²			
Condition	Good Condition			
Comments	Bitumen adhesive	Recommendation	Label & manage	LOW RISK

Building / Site	Room No. Location	Material Description	Material Position	Priority Access Score	Status	Sample no.	Qty	Comments	Condition	Surface Treatment	Asbestos Type	Material Score	Priority Score	Image
Kennington Park Academy	Floor 0: Classroom 4	Bituminous Product	Floor	Usually inaccessible	X-referenced	2	50 m ²	Bitumen adhesive	0	0	Chrysotile	2	6

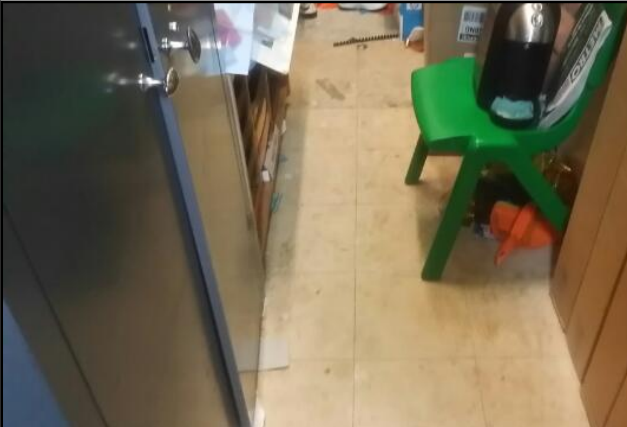
Building	Kennington Park Academy			
Room	Store 1

Accessibility	Medium			
Material Description	Bituminous Product			
Material Position	Floor			
Status	X-referenced			
Sample Ref	2			
Asbestos Type	Chrysotile			
Quantity	4 m ²			
Condition	Good Condition			
Comments	Bitumen adhesive	Recommendation	Label & manage	V.LOW RISK

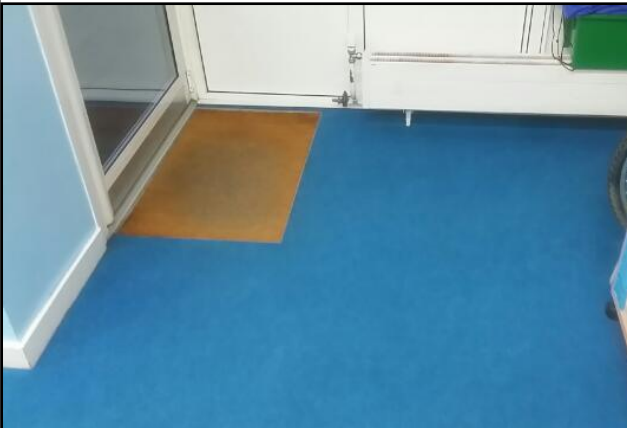
Building	Kennington Park Academy			
Room	Classroom 2

Accessibility	Medium			
Material Description	Bituminous Product			
Material Position	Floor			
Status	X-referenced			
Sample Ref	2			
Asbestos Type	Chrysotile			
Quantity	40 m ²			
Condition	Good Condition			
Comments	Bitumen adhesive	Recommendation	Label & manage	LOW RISK

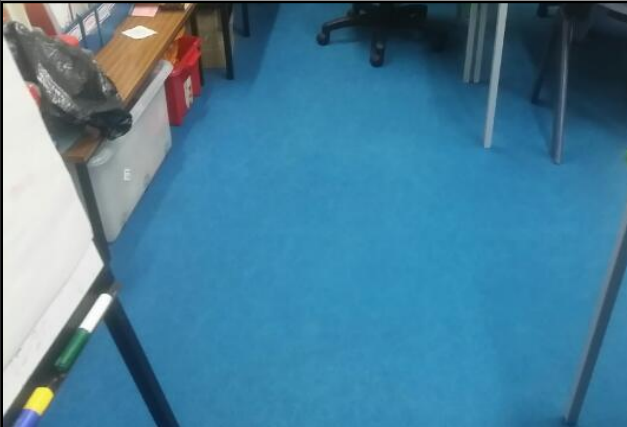
Building	Kennington Park Academy			
Room	Classroom 3			
Accessibility	Medium

Material Description	Bituminous Product			
Material Position	Floor			
Status	X-referenced			
Sample Ref	2			
Asbestos Type	Chrysotile			
Quantity	50 m ²			
Condition	Good Condition			
Comments	Bitumen adhesive	Recommendation	Label & manage	LOW RISK

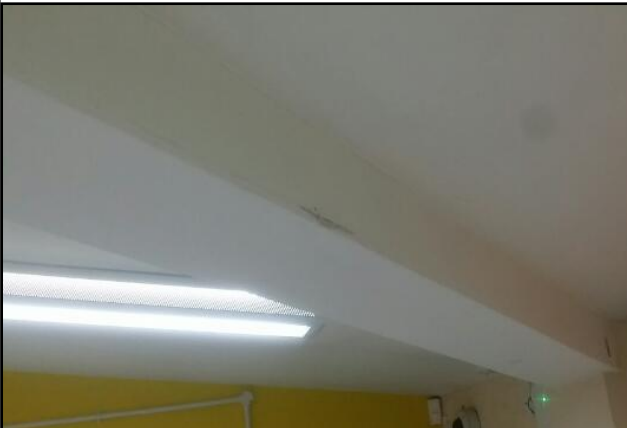
Building	Kennington Park Academy			
Room	Classroom 1			
Accessibility	Medium

Material Description	Insulating Board			
Material Position	Cladding to beam			
Status	Sampled			
Sample Ref	3			
Asbestos Type	Amosite and Chrysotile			
Quantity	7 lin m			
Condition	Good Condition			
Comments	Insulation board cladding to beams	Recommendation	Encapsulate label & manage	MEDIUM RISK

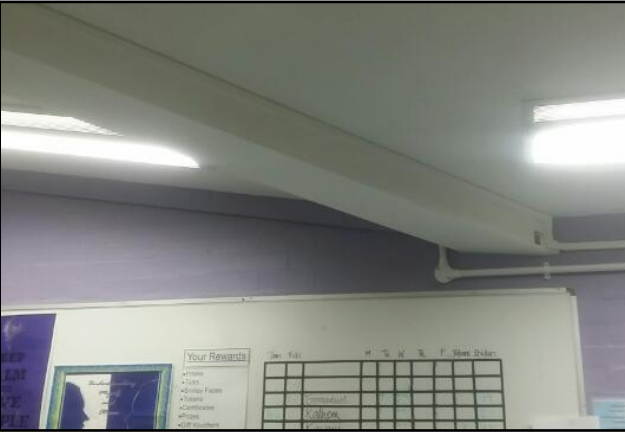
Building	Kennington Park Academy			
Room	Classroom 3			
Accessibility	Medium

Material Description	Insulating Board			
Material Position	Cladding to beam			
Status	X-referenced			
Sample Ref	3			
Asbestos Type	Amosite and Chrysotile			
Quantity	7 lin m			
Condition	Good Condition			
Comments	Insulation board cladding to beams	Recommendation	Manage in situ	MEDIUM RISK

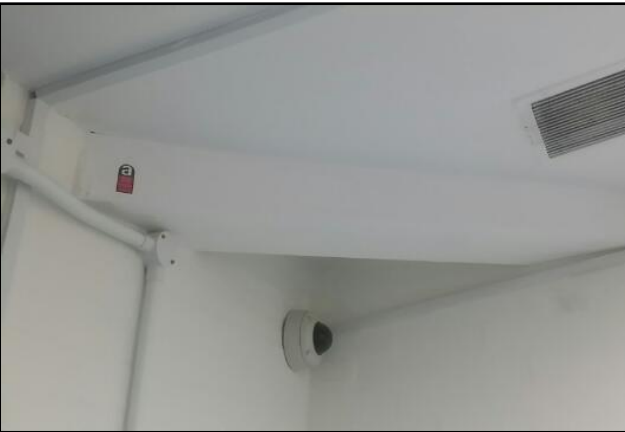
Building	Kennington Park Academy			
Room	Classroom 4			
Accessibility	Medium

Material Description	Insulating Board			
Material Position	Cladding to beam			
Status	X-referenced			
Sample Ref	3			
Asbestos Type	Amosite and Chrysotile			
Quantity	2 lin m			
Condition	Good Condition			
Comments	Insulation board cladding to beams	Recommendation	Manage in situ	MEDIUM RISK

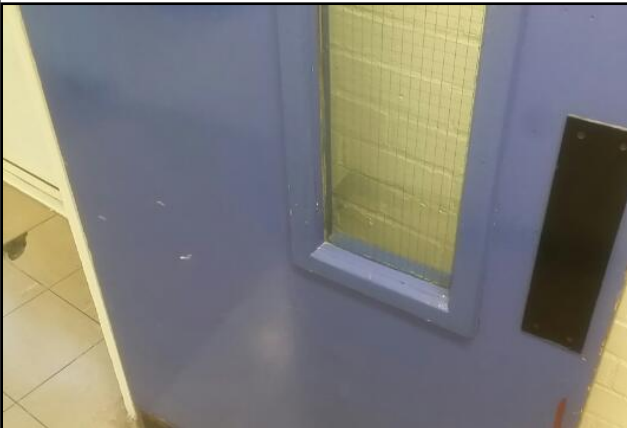
Building	Kennington Park Academy			
Room	Corridor 5			
Accessibility	Easy

Material Description	Insulating Board			
Material Position	Beading			
Status	X-referenced			
Sample Ref	4			
Asbestos Type	Amosite and Chrysotile			
Quantity	4 lin m			
Condition	Good Condition			
Comments	Insulation board beading to fire doors x2 due to the nature of the school I would recommend removal of this item.	Recommendation	Remove	MEDIUM RISK

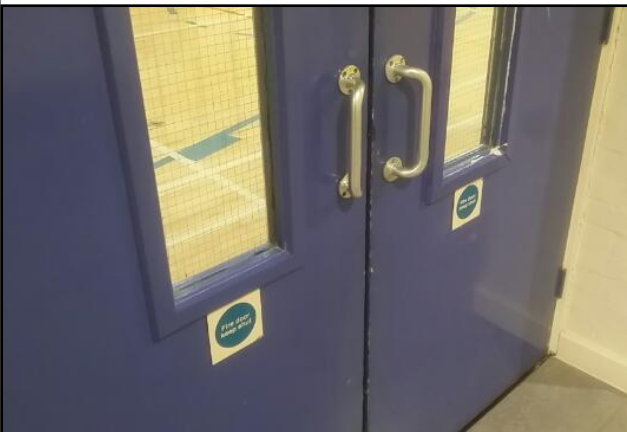
Building	Kennington Park Academy			
Room	Corridor 6			
Accessibility	Easy

Material Description	Insulating Board			
Material Position	Beading			
Status	X-referenced			
Sample Ref	4			
Asbestos Type	Amosite and Chrysotile			
Quantity	4 lin m			
Condition	Good Condition			
Comments	Insulation board beading to fire doors x2 due to the nature of the school I would recommend removal of this item.	Recommendation	Remove	MEDIUM RISK

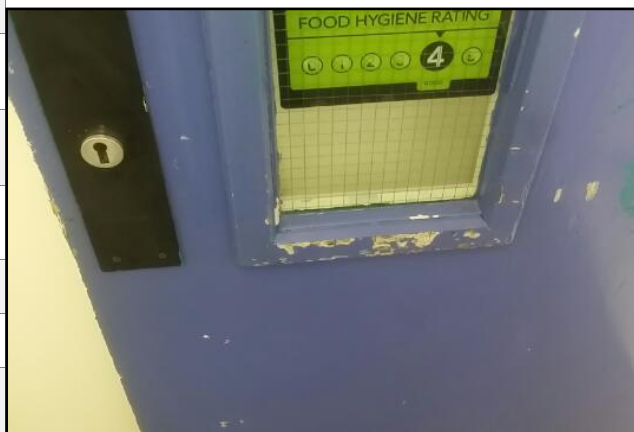
Building	Kennington Park Academy			
Room	Kitchen			
Accessibility	Easy			
Material Description	Insulating Board			
Material Position	Beading			
Status	X-referenced			
Sample Ref	4			
Asbestos Type	Amosite and Chrysotile			
Quantity	4 lin m			
Condition	Good Condition			
Comments	Insulation board beading to fire doors x2 one to w/c and the other to the servery due to the nature of the school I would recommend removal of this item.	Recommendation	Remove	MEDIUM RISK

Kennington Park Academy	Floor 0: Kitchen	Insulating Board	Beading	Routinely Disturbed	X-referenced	4	4 lin m	Insulation board beading to fire doors x2 one to w/c and the other to the servery due to the nature of the school I would recommend removal of this item.	0	2	Amosite and Chrysotile	7	9

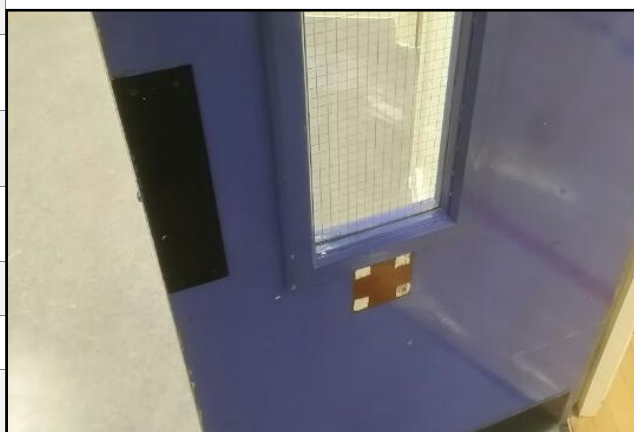
Building	Kennington Park Academy			
Room	Hall			
Accessibility	Easy			
Material Description	Insulating Board			
Material Position	Beading			
Status	X-referenced			
Sample Ref	4			
Asbestos Type	Amosite and Chrysotile			
Quantity	4 lin m			
Condition	Good Condition			
Comments	Insulation board beading to fire doors x2 due to the nature of the school I would recommend removal of this item.	Recommendation	Remove	HIGH RISK

Kennington Park Academy	Floor 0: Hall	Insulating Board	Beading	Routinely Disturbed	X-referenced	4	4 lin m	Insulation board beading to fire doors x2 due to the nature of the school I would recommend removal of this item.	0	2	Amosite and Chrysotile	7	10

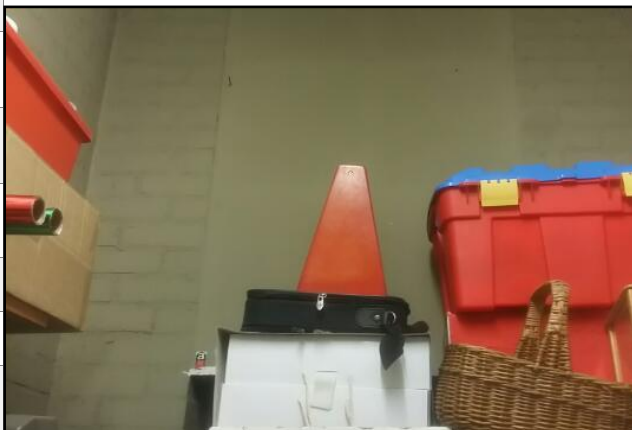
Building	Kennington Park Academy			
Room	Store 3			
Accessibility	Medium			
Material Description	Insulating Board			
Material Position	Cladding to beam			
Status	Sampled			
Sample Ref	5			
Asbestos Type	Amosite and Chrysotile			
Quantity	2 m ²			
Condition	Good Condition			
Comments	Insulation board cladding to beams	Recommendation	Manage in situ	LOW RISK

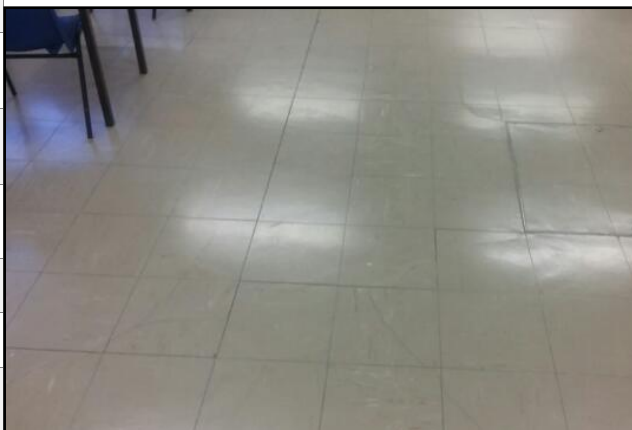
Building	Kennington Park Academy			
Room	Dining room			
Accessibility	Medium			
Material Description	Bituminous Product			
Material Position	Floor			
Status	Sampled			
Sample Ref	8			
Asbestos Type	Chrysotile			
Quantity	80 m ²			
Condition	Low Damage			
Comments	Bitumen adhesive	Recommendation	Repair, seal, label & manage	LOW RISK

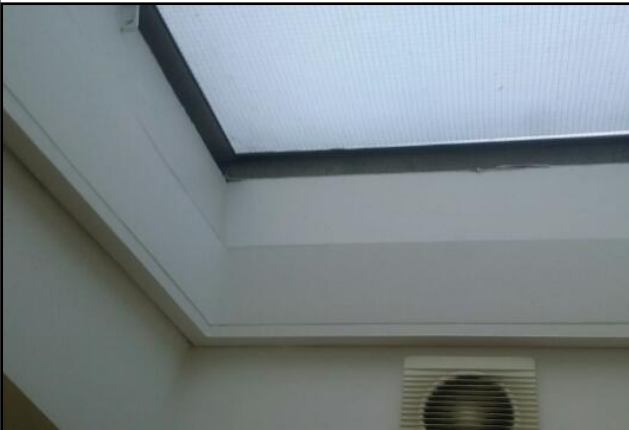
Building	Kennington Park Academy			
Room	Disable w/c

Accessibility	Difficult			
Material Description	Mastic			
Material Position	Skylight			
Status	X-referenced			
Sample Ref	9			
Asbestos Type	Chrysotile			
Quantity	4 lin m			
Condition	Low Damage			
Comments	Mastic to skylight	Recommendation	Label & manage	LOW RISK

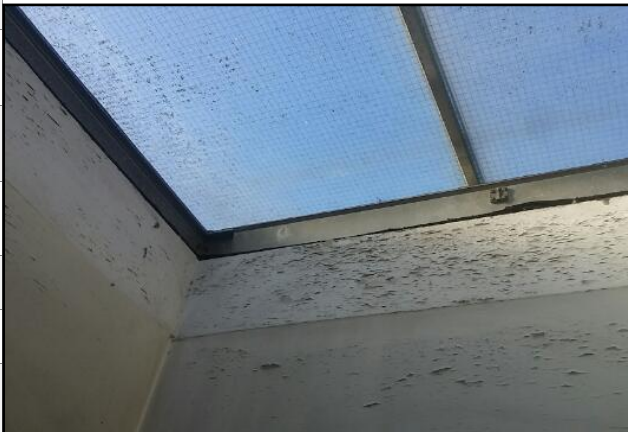
Room	Laundry			
Accessibility	Difficult			
Material Description	Mastic			
Material Position	Skylight			
Status	X-referenced			
Sample Ref	9			
Asbestos Type	Chrysotile			
Quantity	4 lin m			
Condition	Low Damage			
Comments	Mastic to skylight	Recommendation	Label & manage	V.LOW RISK

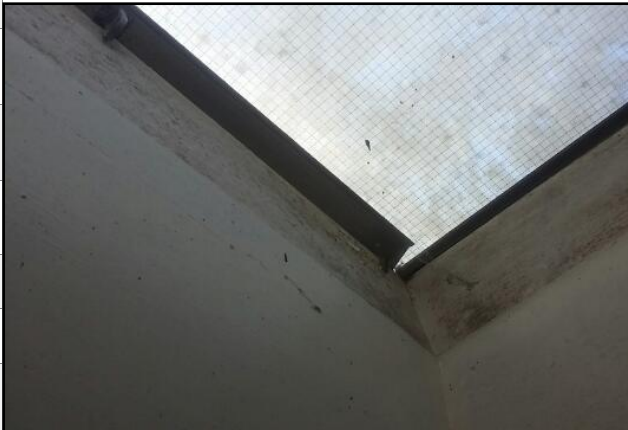
Room	Store 4			
Accessibility	Difficult			
Material Description	Mastic			
Material Position	Skylight			
Status	X-referenced			
Sample Ref	9			
Asbestos Type	Chrysotile			
Quantity	4 lin m			
Condition	Low Damage			
Comments	Mastic to skylight	Recommendation	Label & manage	V.LOW RISK

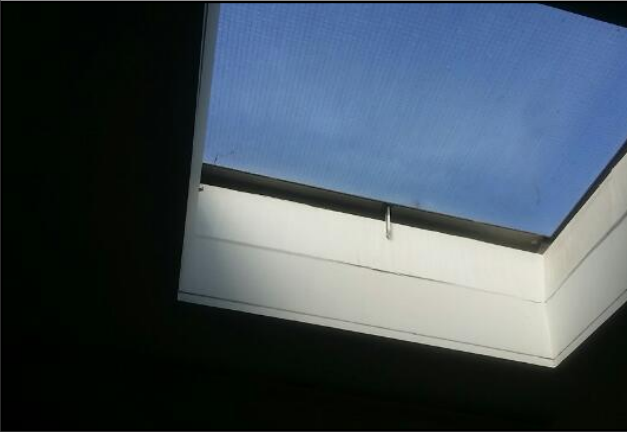
Building	Kennington Park Academy			
Room	Female w/c

Accessibility	Difficult			
Material Description	Mastic			
Material Position	Skylight			
Status	X-referenced			
Sample Ref	9			
Asbestos Type	Chrysotile			
Quantity	4 lin m			
Condition	Low Damage			
Comments	Mastic to skylight	Recommendation	Label & manage	LOW RISK

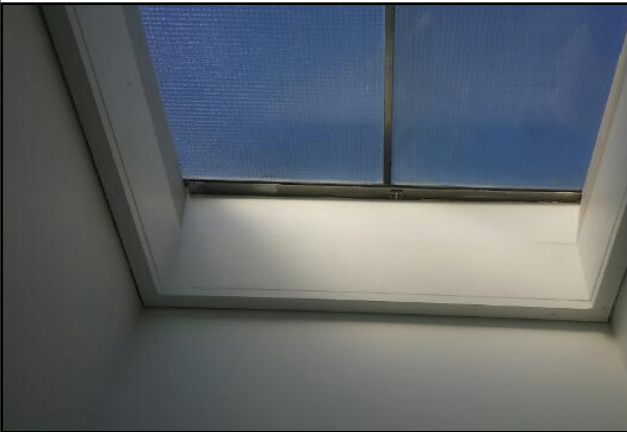
Building	Kennington Park Academy			
Room	Male w/c

Accessibility	Difficult			
Material Description	Mastic			
Material Position	Skylight			
Status	X-referenced			
Sample Ref	9			
Asbestos Type	Chrysotile			
Quantity	8 lin m			
Condition	Low Damage			
Comments	Mastic to skylight x2	Recommendation	Label & manage	LOW RISK

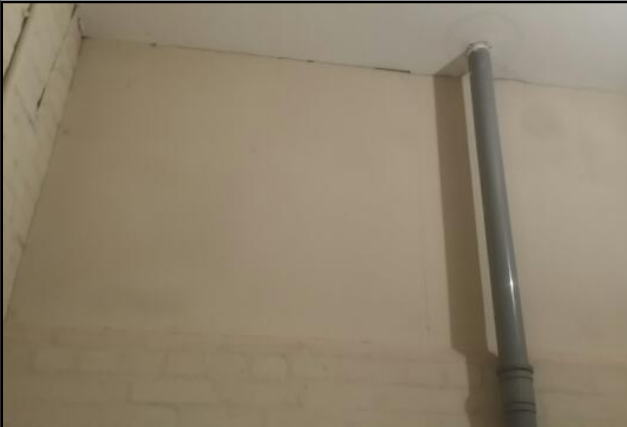
Building	Kennington Park Academy			
Room	Tank cup

Accessibility	Medium			
Material Description	Insulating Board			
Material Position	Internal Wall			
Status	Sampled			
Sample Ref	10			
Asbestos Type	Amosite and Chrysotile			
Quantity	4 m ²			
Condition	Medium Damage			
Comments	Insulation board panel to either side of wall this is damage where the pipes pass through	Recommendation	Repair, seal, label & manage	MEDIUM RISK

Kennington Park Academy	Floor 0: Tank cup	Insulating Board	Internal Wall	Usually inaccessible	Sampled	10	4 m ²	Insulation board panel to either side of wall this is damage where the pipes pass through	2	2	Amosite and Chrysotile	9	3

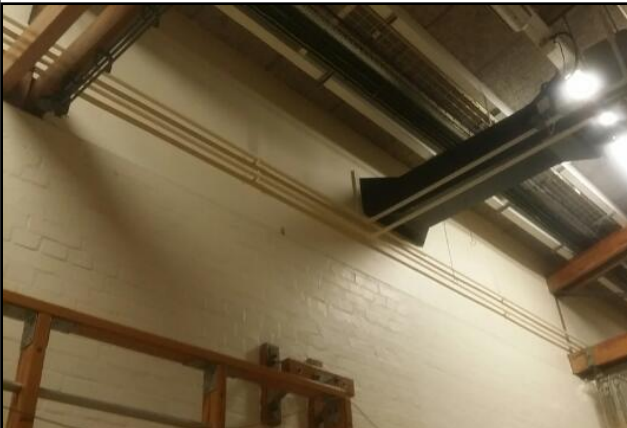
Building	Kennington Park Academy			
Room	Hall

Accessibility	Medium			
Material Description	Insulating Board			
Material Position	Internal Wall			
Status	X-referenced			
Sample Ref	10			
Asbestos Type	Amosite and Chrysotile			
Quantity	50 m ²			
Condition	Good Condition			
Comments	Insulation board panel at high level to either side of wall	Recommendation	Label & manage	LOW RISK

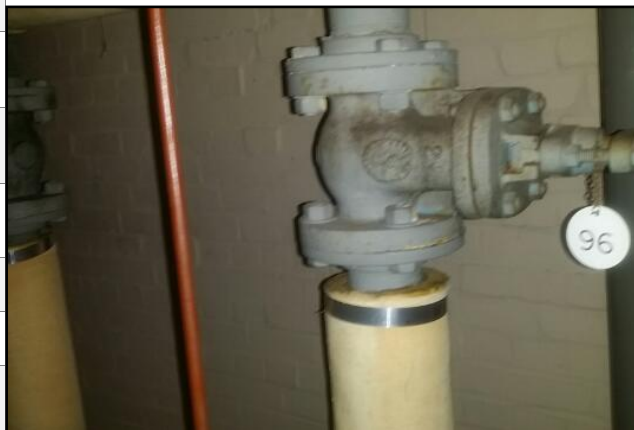
Building	Kennington Park Academy			
Room	Tank cup			
Accessibility	Medium			
Material Description	Gasket			
Material Position	Pipework			
Status	Sampled			
Sample Ref	11			
Asbestos Type	Chrysotile			
Quantity	6 lin m			
Condition	Good Condition			
Comments	Gaskets to pipework	Recommendation	Label & manage	V.LOW RISK

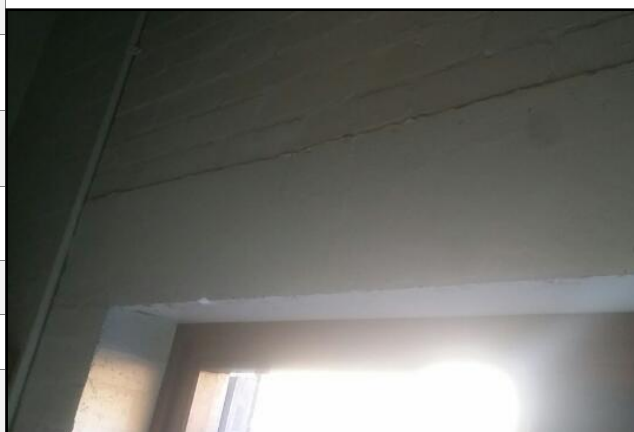
Building	Kennington Park Academy			
Room	Gas Meter Cupboard 1			
Accessibility	Medium			
Material Description	Insulating Board			
Material Position	Boxing			
Status	Sampled			
Sample Ref	12			
Asbestos Type	Amosite and Chrysotile			
Quantity	1 m ²			
Condition	Low Damage			
Comments	Insulation board boxing above door	Recommendation	Encapsulate label & manage	MEDIUM RISK

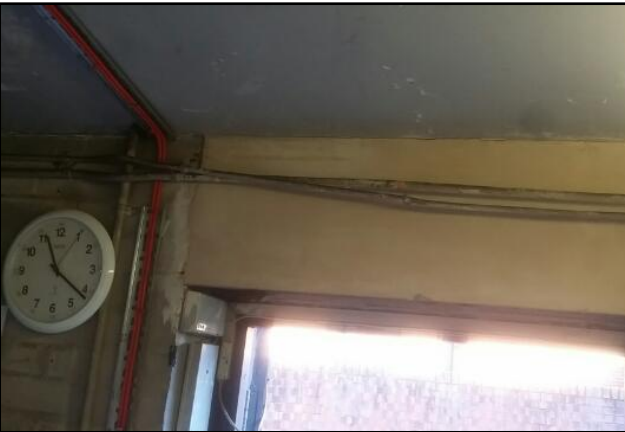
Building	Kennington Park Academy			
Room	Boiler room

Accessibility	Medium			
Material Description	Insulating Board			
Material Position	Boxing			
Status	X-referenced			
Sample Ref	12			
Asbestos Type	Amosite and Chrysotile			
Quantity	1 m ²			
Condition	Low Damage			
Comments	Insulation board boxing above door. Could have been over boarded with plasterboard no paperwork to prove it has been removed.	Recommendation	Encapsulate label & manage	MEDIUM RISK
