# **ACCESSIBILITY AUDIT 2017**

## **Access to the premises**

**Date:** March 2017

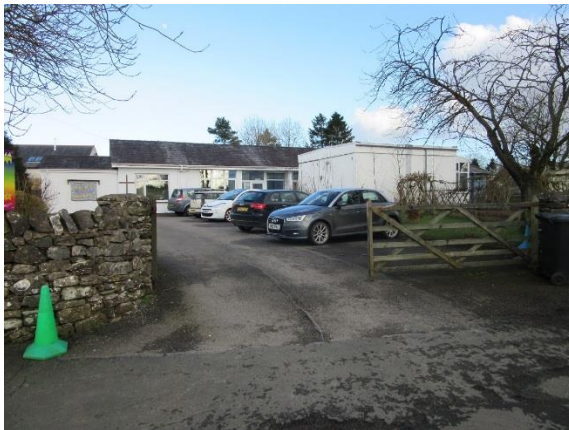
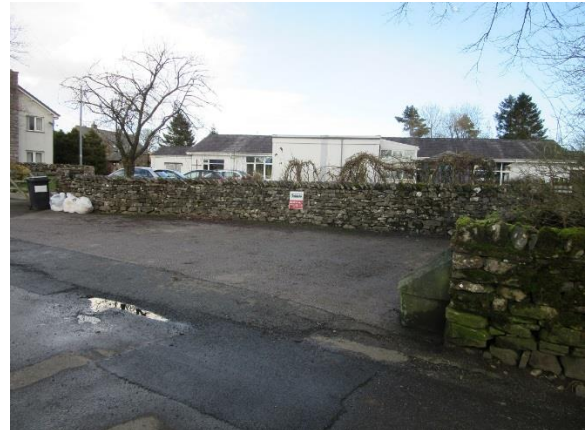
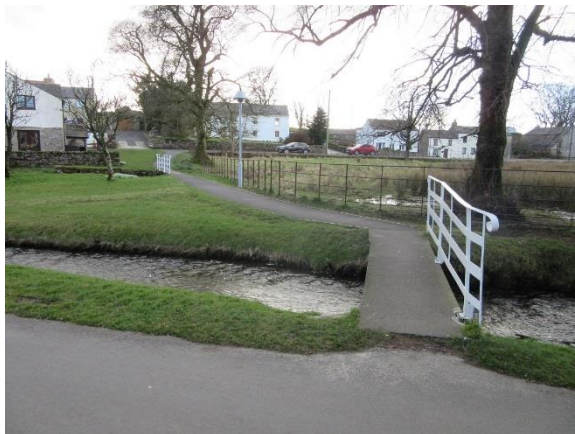
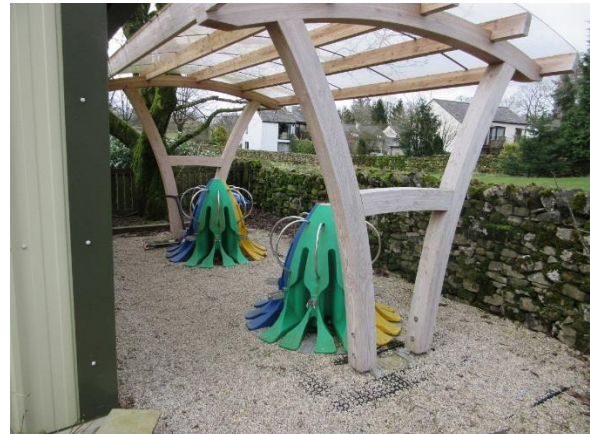
### PARKING

Staff parking is provided on the premises. Children arrive by school bus, on foot or by bike. The school buses park in a bus bay (unmarked) immediately outside the school gate. Parents usually park on the nearby roads & walk their children to the playground/relevant classroom entrance. There is a covered bike park in the school grounds.

Recommendation	Priority	Type of improvement	Accessibility issue(s) addressed
<b>Parking &amp; approach</b>			
1. Provide a designated parking space for people with reduced mobility – outside the gate, in the bus bay or in the staff car park	4	Major	W, A

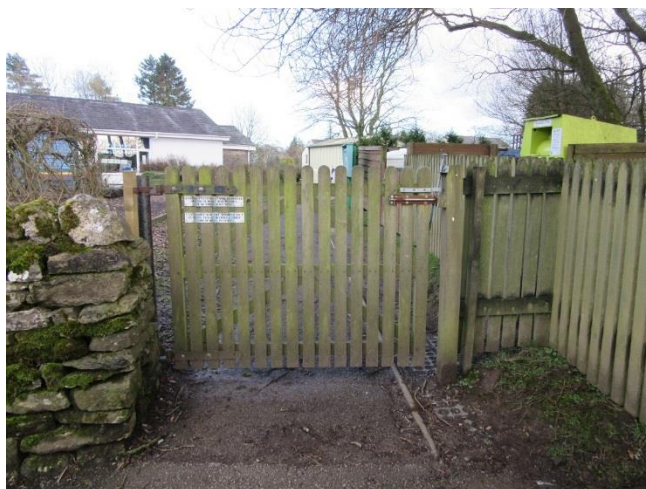
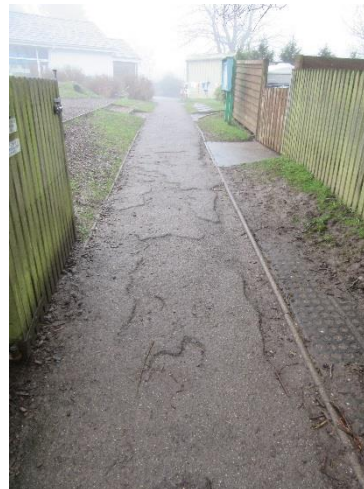
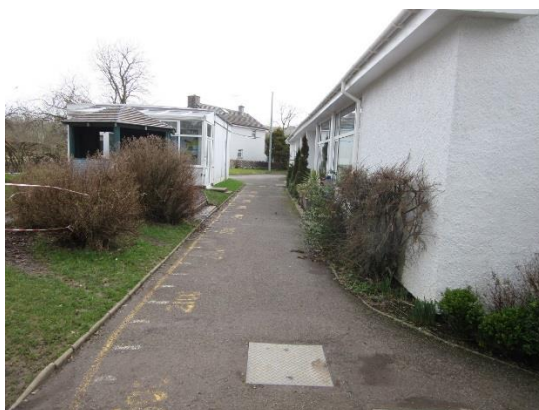
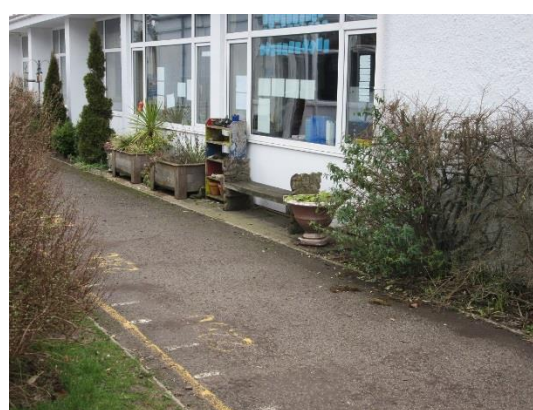
### APPROACH

The school is approached via a gate & tarmac pedestrian path. It is 30 metres from the gate to the playground, & a further 30 metres along the front of the school to the main (visitor) entrance. There is a bench alongside the path on the front of the school, if needed. There is a main school sign adjacent to the vehicular gate, but no directional signage on the pedestrian approach route.

3. Resurface the pedestrian path surface – the tarmac has degraded & the uneven surface currently represents a trip hazard to all, as well as making access more difficult for those with impaired mobility	1	Major	W, A, V

4. Trim down-hanging tree branches near the gate to provide >2m clearance	2	Minor	A, V
5. Paint the wooden bench adjacent to the front path to make it more 'visible'	3	Minor	A, V

6. Provide signage on the first corner of the building with directions to the main entrance & classrooms	2	Minor	C (all)
7. Install external lighting for the pedestrian approach, staff car park & fire assembly point – the building is now routinely used until 5.30pm, by which time it is dark in the winter	2	Major	V (all)

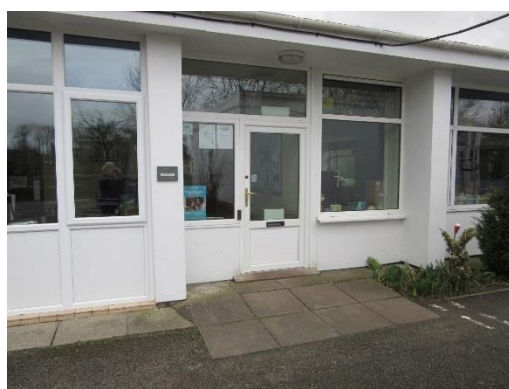
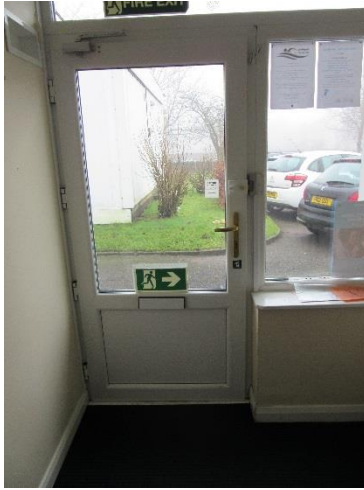
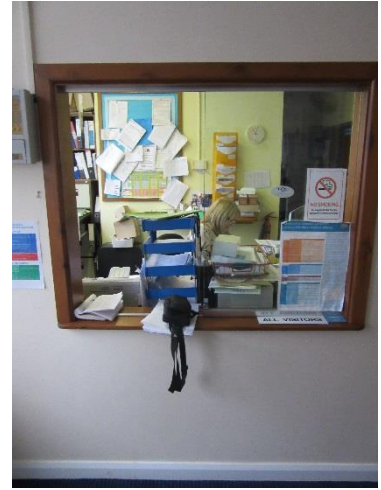
## MAIN ENTRANCE

The main entrance to the school is generally accessible. There is a (paved) ramp outside, the entry-phone system should be accessible to wheelchair users, door handles are easily distinguished from their background (gold on white, silver on maroon), there are no obstructions in the lobby, the floor is carpeted throughout, safety signage is at low level & the hatch is at a level accessible to seated or standing visitors.

The main school building is on one level throughout.

<b>Main entrance</b>			
8. Provide a (tactile) sign to identify the main entrance for visitors – this might also help to distinguish the door from its surround	3	Minor	V, C

9. Provide signage at the main entrance explaining how to summon assistance, if required	2	Minor	W, A, V
10. Replace the door from the lobby to the hall with one which allows visibility for wheelchair users (unless there are privacy reasons for retaining the existing door which only has standing visibility)	4	Major	W

11. Provide a clearer (ie less 'busy') background to the hatch so that it is less distracting for people with visual or hearing impairment	3	Working practice	V, H

12. Providing signage & a (tactile) map in the main reception lobby to help people find their way to other parts of the building	2	Minor	V, C
<b>Other entrances</b>

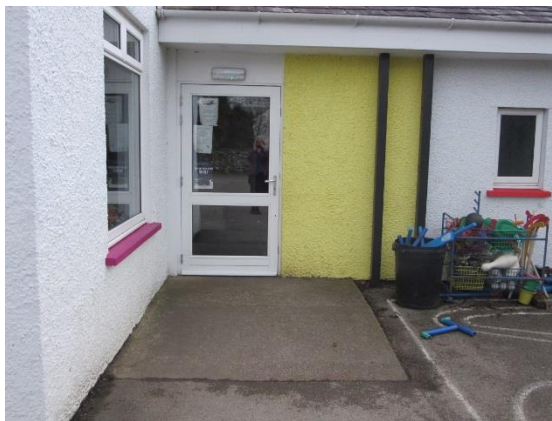
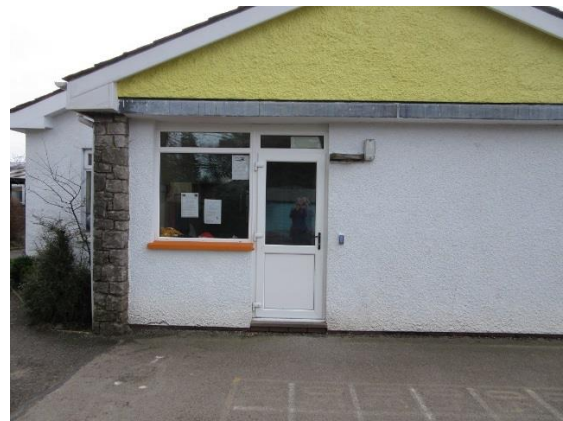
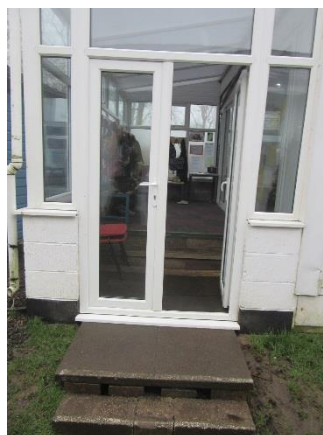
## OTHER ENTRANCES

Pupils also enter the school via the cloakrooms. The door Class 1/2's cloakroom is wheelchair accessible, whereas Class 3's external door has a small step & Class 4 is accessed by 4 steps. An electronic entry system has recently been installed on Class 3's entrance to allow Class 4 children to access the cloakroom independently.

13. Change the lower pane of Class 3's door to toughened glass to improve visibility (unless there are privacy considerations, eg changing for PE)	3	Major	W

14. Provide a ramp outside Class 3's external door	3	Minor	W
15. When Class 4 is replaced, ensure that ramped access is incorporated in the design	4	Major	W
<b>Hall</b>

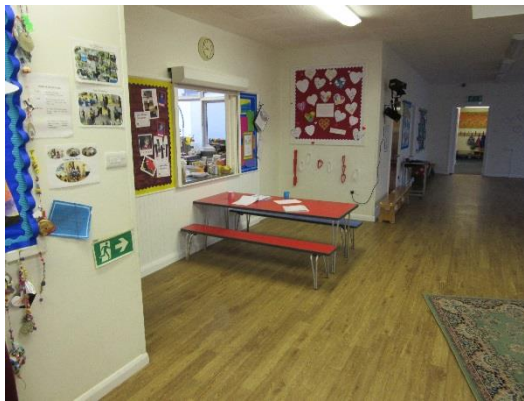
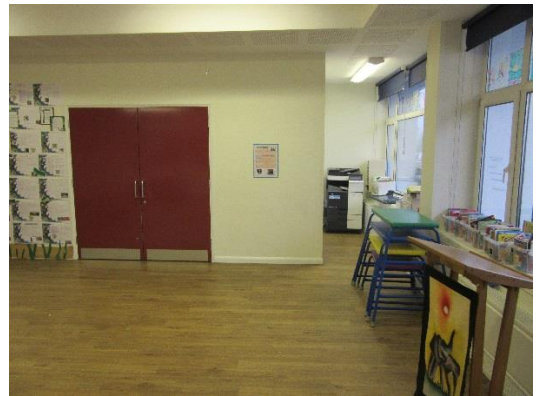
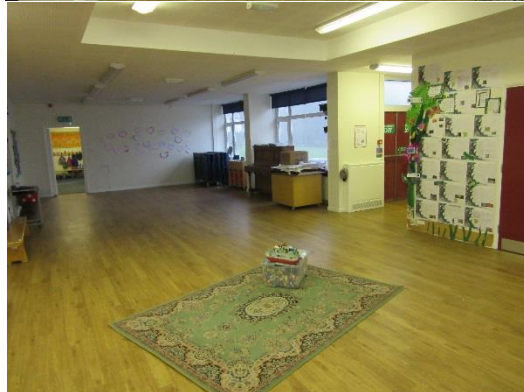
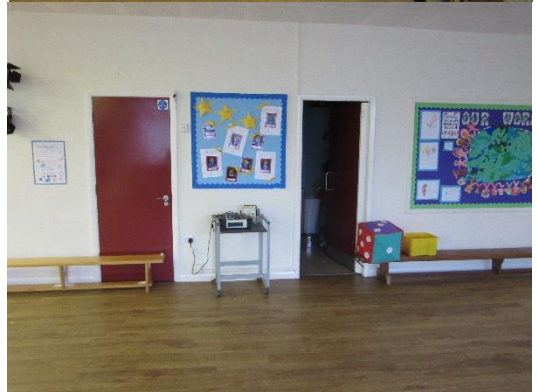
## HALL

The hall is a multi-functional space. It is used daily for assemblies, lunches, indoor PE activities, small group learning support, after-school club, etc. Tables & benches are stored in a large cupboard, but some PE & music equipment is stored in the hall due to lack of handy storage capacity.

The floor is non-slip wood-effect vinyl.

16. Remove obstructions present in the hall (benches, sports equipment, etc)	3	Working practice	W, A, V
17. Paint the walls a pale colour when next redecorating, to improve contrast between walls & door frames/skirting/light switches/sockets (also applies to other areas, eg classrooms)	2	Minor	V

18. Consider moving switches to a lower height when any major refurbishment work is undertaken	4	Major	W
<b>Corridor from hall to Class 1/2</b>			
19. Paint the door maroon to distinguish it from the frame & handle	3	Minor	V

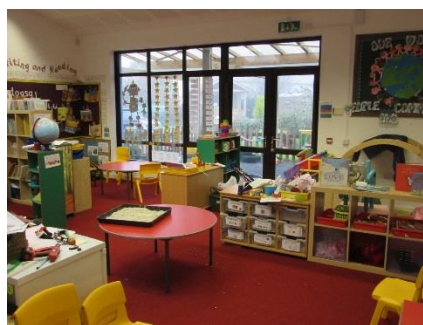
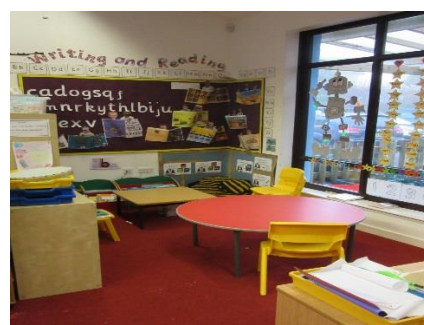
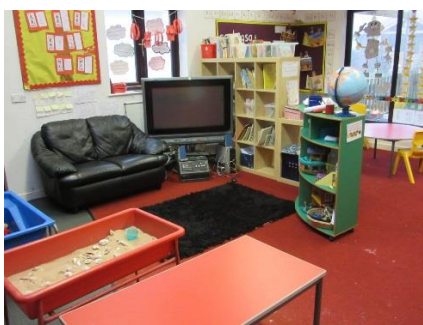
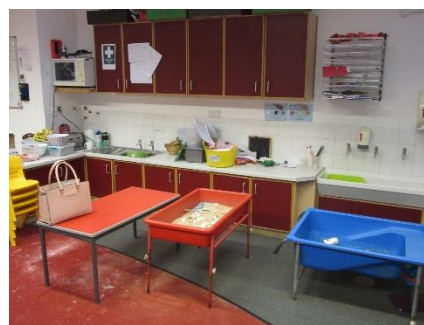
## CLASS 1

Class 1 is used for Early Years & Foundation Stage (Nursery & Reception). The classroom is divided into a number of different 'zones' – including areas for wet/sand play, reading/writing, stories/watching TV, & using computers. There is a small 'quiet room' within the classroom. Toilet facilities are located within the classroom. There is a covered play area outside the classroom.

24. Change colour of tables or carpet (whichever needs replacing first) to improve visual contrast – currently red on red (although the yellow chairs do help)	3	Major	V

25. Paint the walls a pastel or bold colour to improve visual contrast between walls/switches & door frame (Class 1 is due to be repainted in summer 2017)	2	Minor	V
<b>Class 2</b>

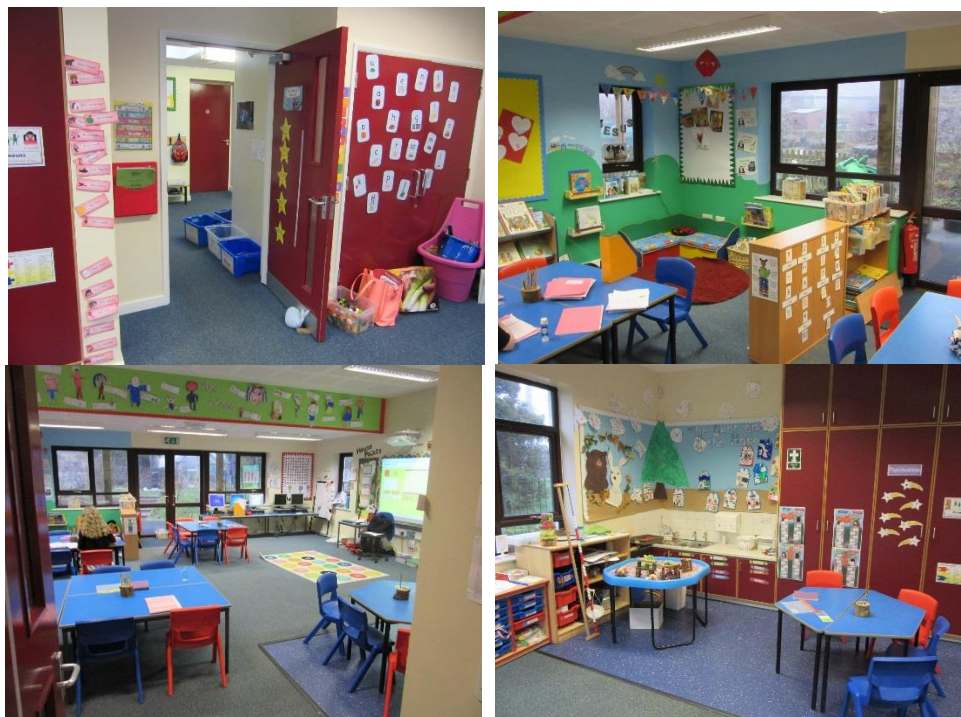
## CLASS 2

Class 2 is currently used for Year 1/2. The main area of the class has a number of tables. There is also a 'quiet corner' for reading, & a small IT area. There is an outside covered play area. Toilet facilities are located just outside the classroom.

26. Change colour of tables or carpet (whichever needs replacing first) to improve visual contrast – currently blue on blue	3	Major	V
27. Change position of tables to improve access to emergency exit (double doors)	2	Working practice	W, A, V
<b>Class 3</b>

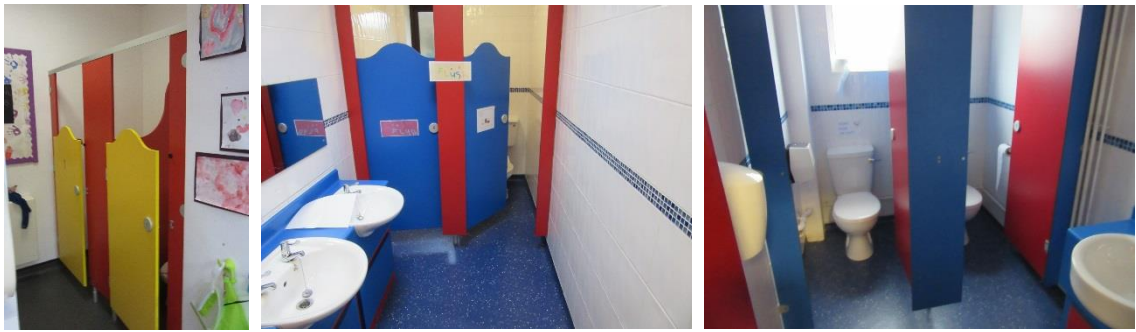
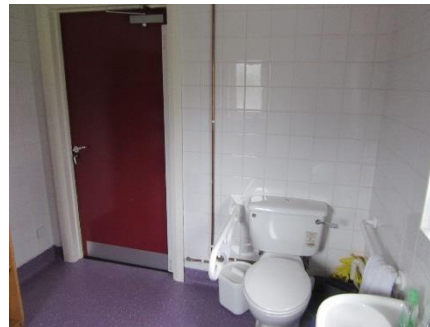
## TOILET FACILITIES

The toilet facilities serving Class 1, Class 2 & Class 3/4 have all been installed or upgraded recently, & meet accessible design standards.

There is also an accessible WC.

34. Replace the locks in all toilet cubicles with lever-type locks, which are easier for those with limited dexterity to use & which can be opened from outside (using a screwdriver) if necessary	2	Minor	D

35. Install a panic cord/alarm system in the accessible WC	4	Major	W
36. Replace the handrails in the accessible WC with coloured ones (or paint the existing ones if possible) to improve visual contrast	3	Minor	V
<b>Emergency exits</b>

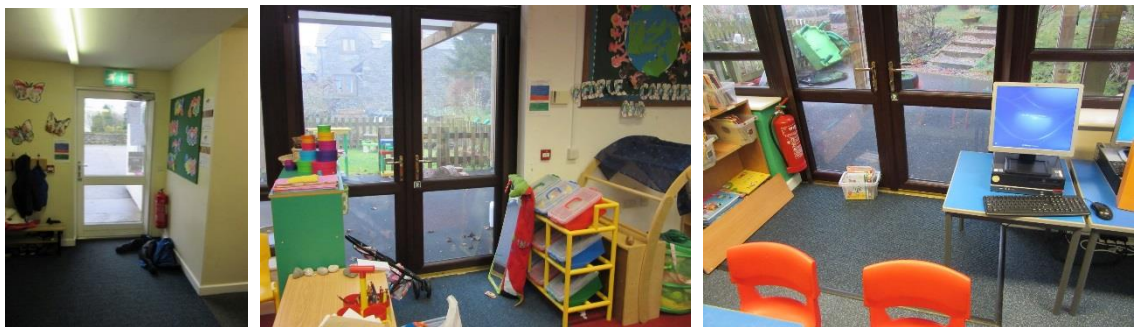
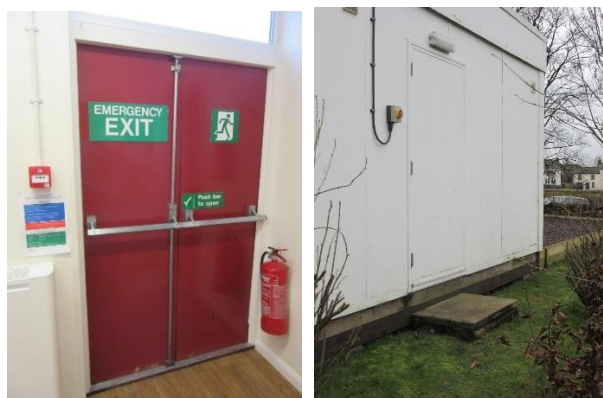
## EMERGENCY EXITS

All the school's entrance doors are also used as emergency exits. The exits to the outside play areas from Class 1 & Class 2 double as fire exits (although the main fire evacuation route for these classes is via their shared cloakroom/entrance door). In Class 3 & Class 4, the entrance is also the principal evacuation route. The hall & the kitchen also have fire exits.

37. Add low-level pictogram signage on all emergency exits – this would be easier for children to see, as well as wheelchair users	2	Minor	W, V, C
38. Ensure that emergency escape routes & emergency exits are kept clear at all times – this may require relocation of fire extinguishers, IT & play equipment, & bag/shoe storage trolley which are currently partially obstructing exits or escape routes from Class 1, Class 2 & the hall	1	Working practice	All

39. Provide ramps outside fire exits from the hall (double doors), Class 3 & Class 4 so that they are suitable for wheelchair users	3	Minor (Class 4 major)	W

40. Provide appropriate signage on the outside of the fire exits & ensure they are kept clear	3	Minor	-
41. Provide lighting & signage identifying fire assembly area	3	Minor	All

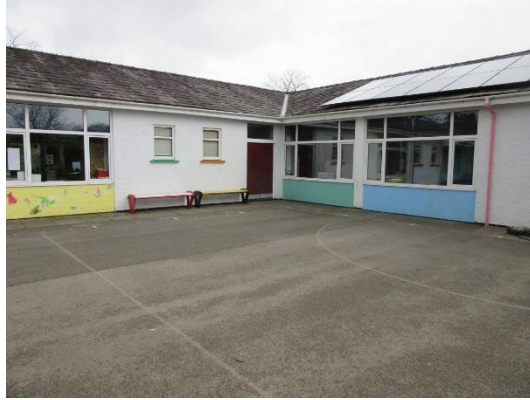
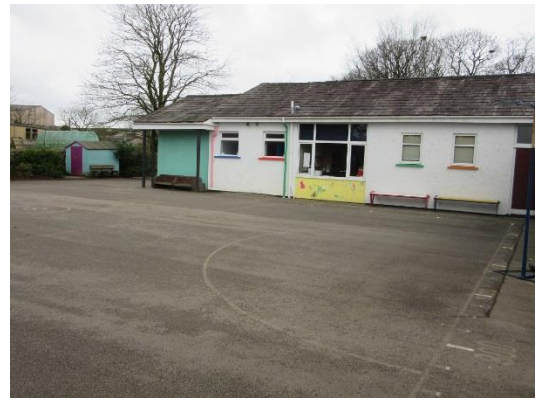
The main playground is tarmac, & provides space for ball games & outdoor PE activities.

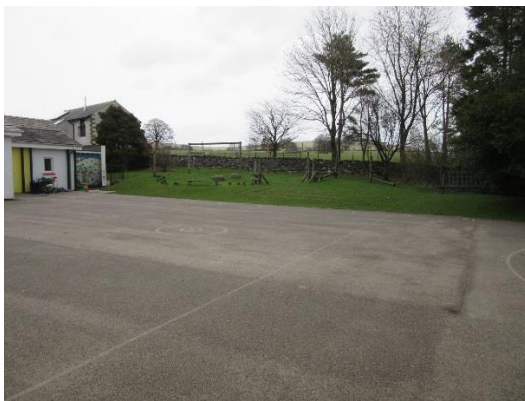
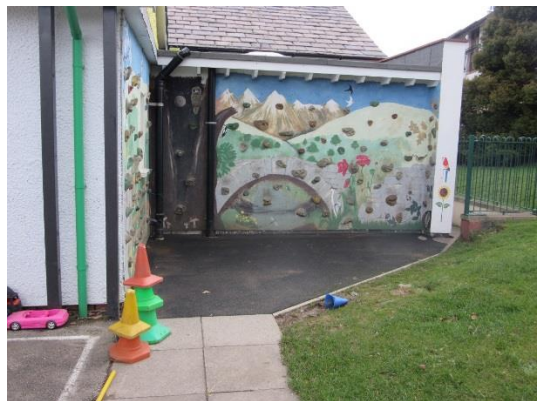
There is a grassed area with an adventure trail adjacent to the main playground, & a climbing wall.

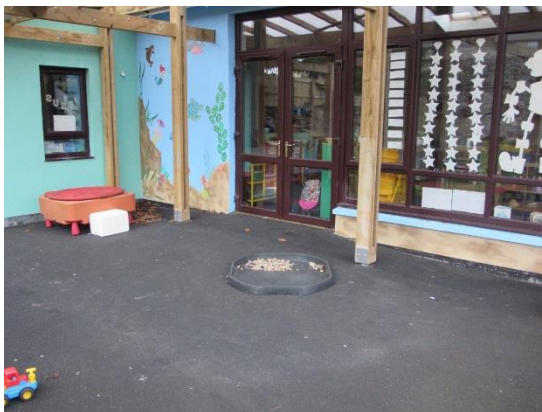
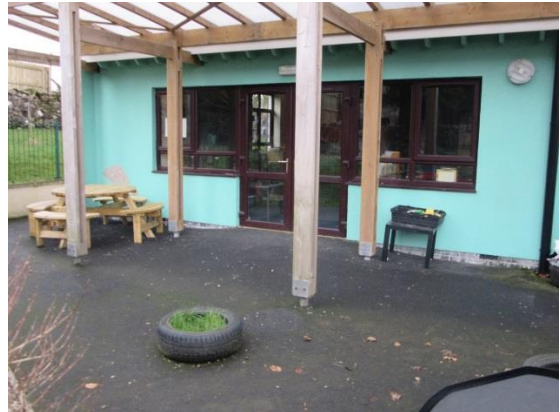
There are smaller play areas outside Class 1 & Class 2, which have 'soft tarmac' surfaces. The exit from Class 1 has a small gradient (ramp).

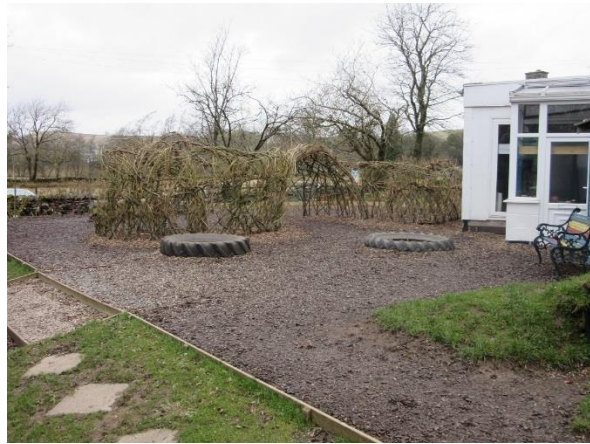
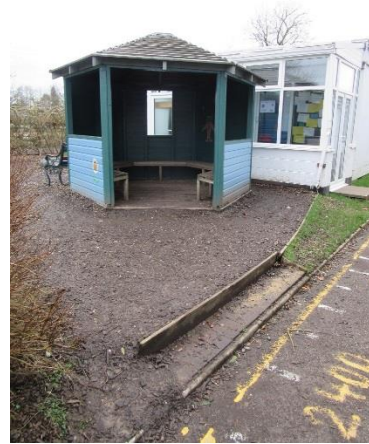
The willow sculpture & friendship hut at the front of the school are accessed by steps.

43. Repaint the lines on the playground (& add around the edge if necessary) to help identify the ‘boundaries’	2	Minor	V
44. Ensure steps to willow sculpture/friendship hut & productive garden meet accessible design requirements (consistent tread length/riser height within specified limits, nosings clearly indicated)	2	Minor	A, V

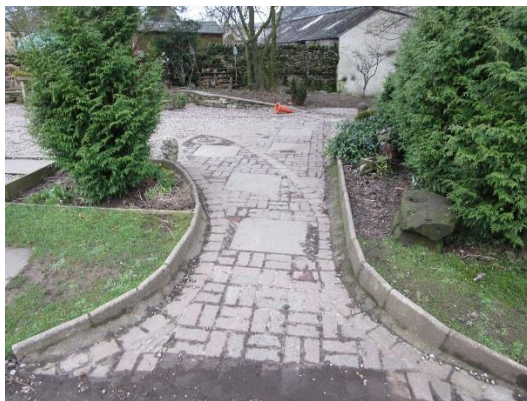
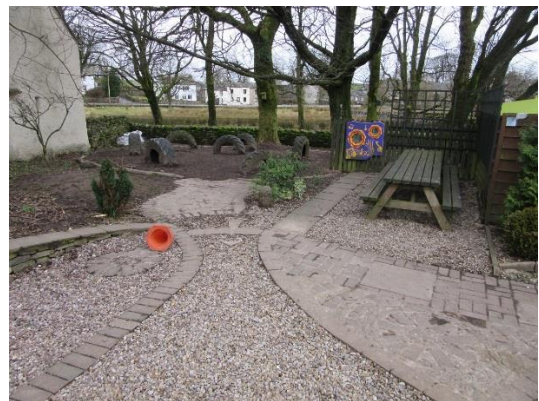
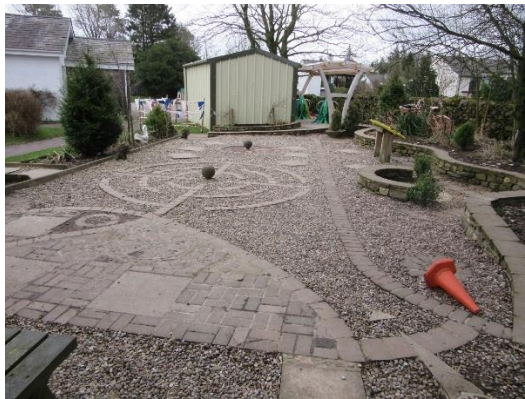
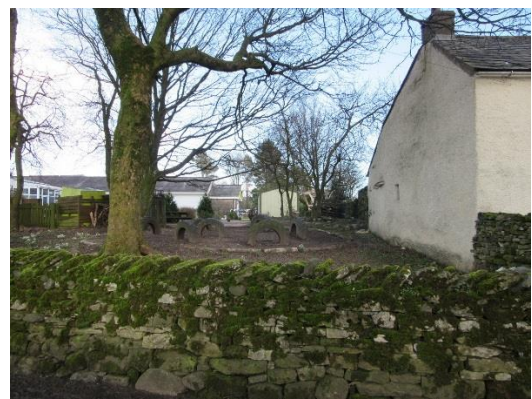
The Jubilee Garden was developed in ~2014 & provides additional space for play or learning – including opportunities for tree climbing. It has (steep) ramped access, but has loose stones & some low-level obstacles in the main area.

45. Add ramps to enable wheelchair access to the garden areas if the need arises	4	Major	W
<b>General</b>			
46. Consider need for an induction loop system	4	Major	H

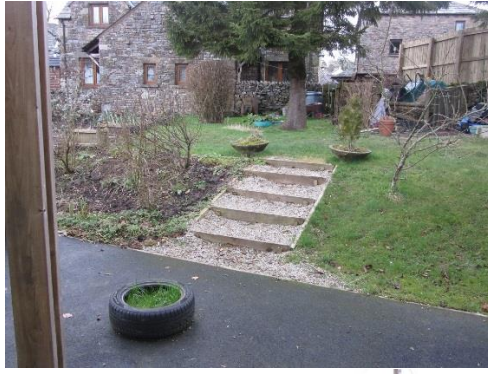
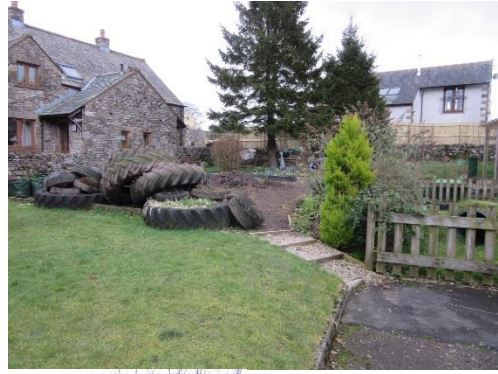
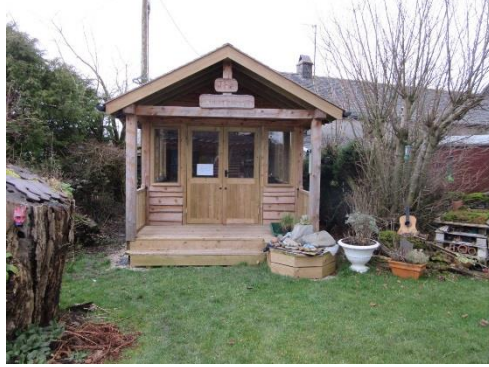
The productive garden is used to grow fruit & vegetables, & also has wildlife-friendly areas including a nectar bar & bug hotel. The Potting Shed was installed in 2016, & provides a covered facility for gardening club or other outdoor activities. Both are accessed by steps.

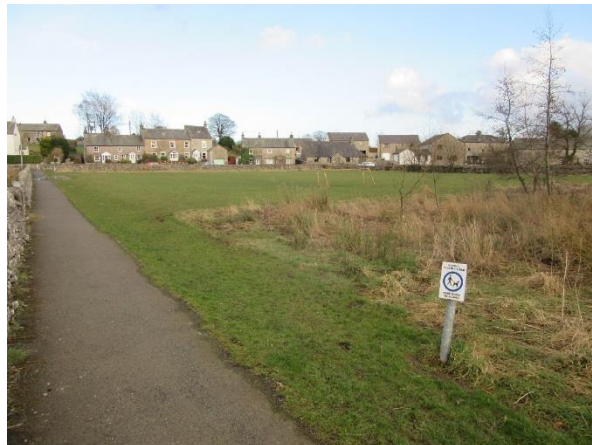
There is also a school playing field, located in the centre of the village – approximately 270 metres from the school along a (quiet) single track road.
