ASBESTOS MANAGEMENT SURVEY

Client Name:	Direct 365 Online Ltd
Client Contact:	Sasha Deegan
Client Address:	Direct 365 Online Ltd Oasis Business Park Skelmersdale WN8 9RD
Address of premises surveyed:	Kennington Park Academy 20 Kennington Park Gardens Kennington SE11 4AX
Type(s) of survey undertaken:	Management
Survey Date(s):	17/01/2019
Report No:	E-72310
Surveyor / Authorisation:	Andrew Rogers – Asbestos Surveyor
Report Date:	23/01/2019
Q.C Check by:	Andrew Rogers

Kennington Park Academy, 20 Kennington Park Gardens, Kennington, SE11 4AX

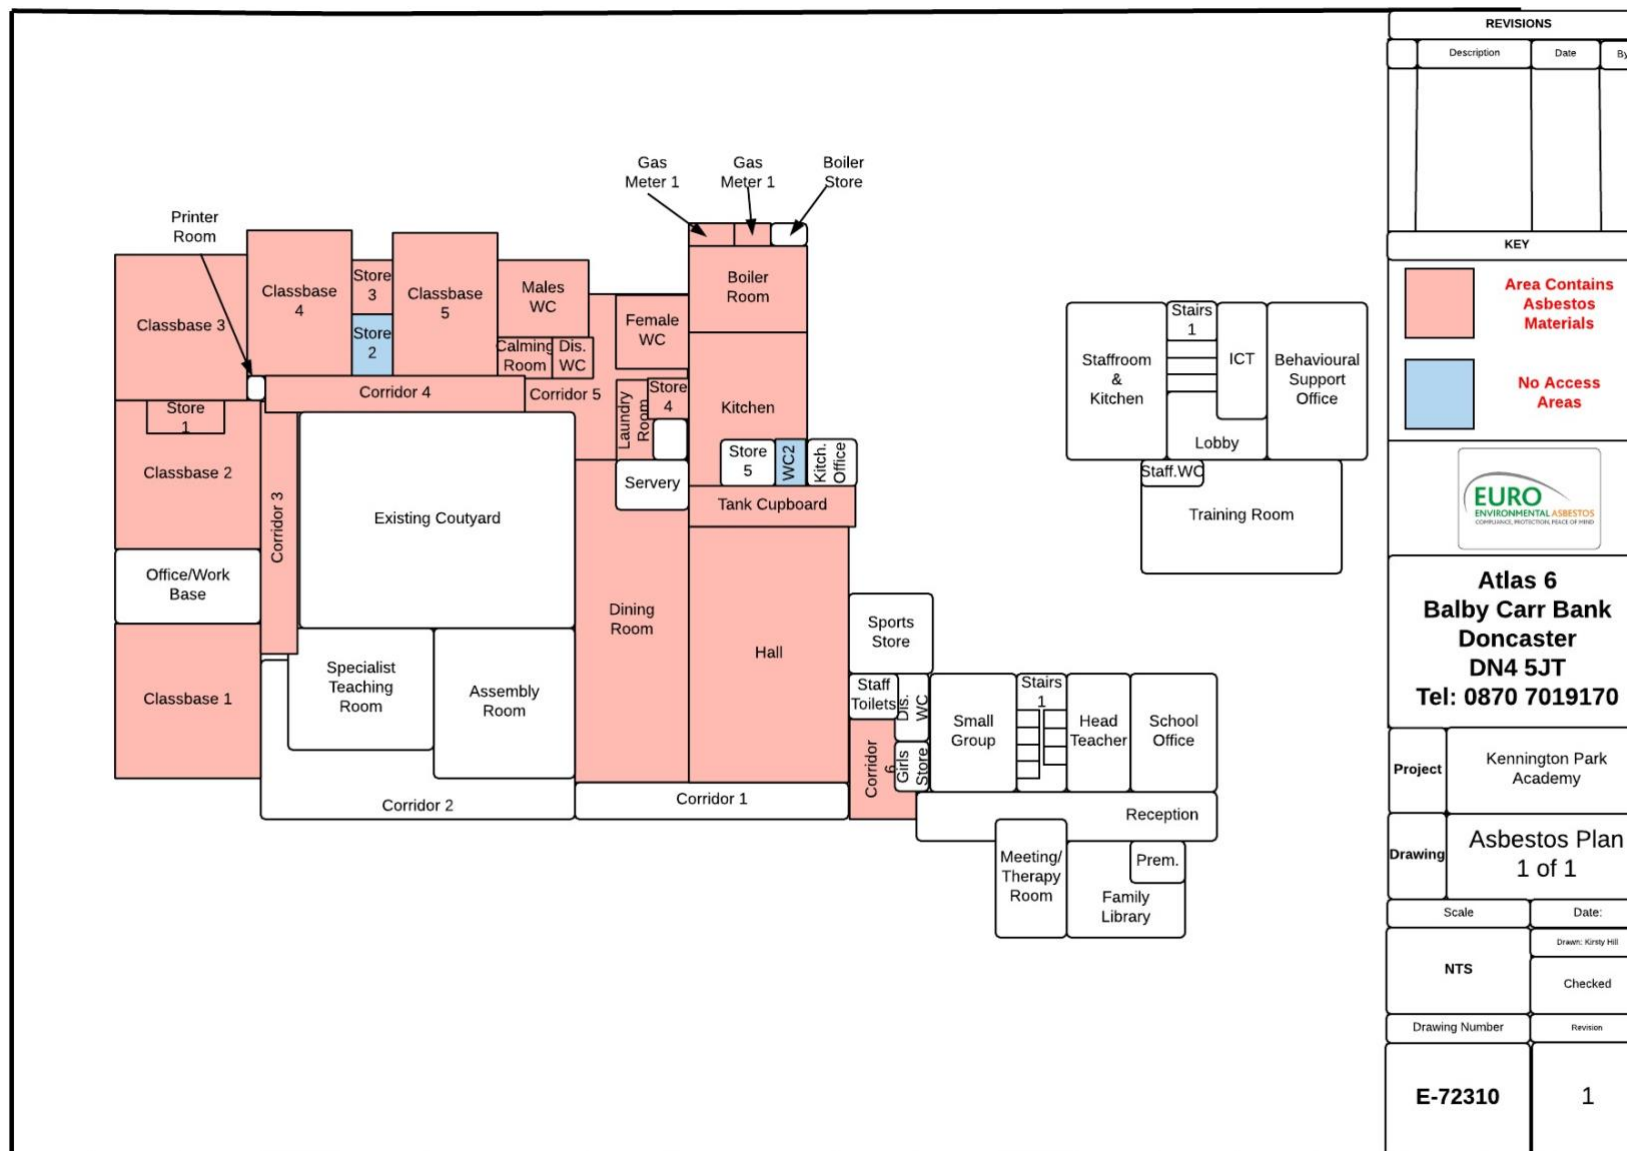
[Appendix A displays the location of positively sampled, presumed & strongly presumed materials and areas of no access. Red cross-hatching denotes areas where asbestos materials are present while the orange cross hatching indicates areas of no access, all areas of no access should be considered to contain asbestos until proven otherwise]
